موضوع: ارسال فرصت های همکاری با گروه Motlekar آفریقای جنوبی

## **OTTOSHOEP HISTORIC GOLD MINE**

### **RECOMMENDED WORK PROGRAMME FOR THE EVALUATION OF THE ECONOMIC POTENTIAL OF HISTORIC DUMPS**

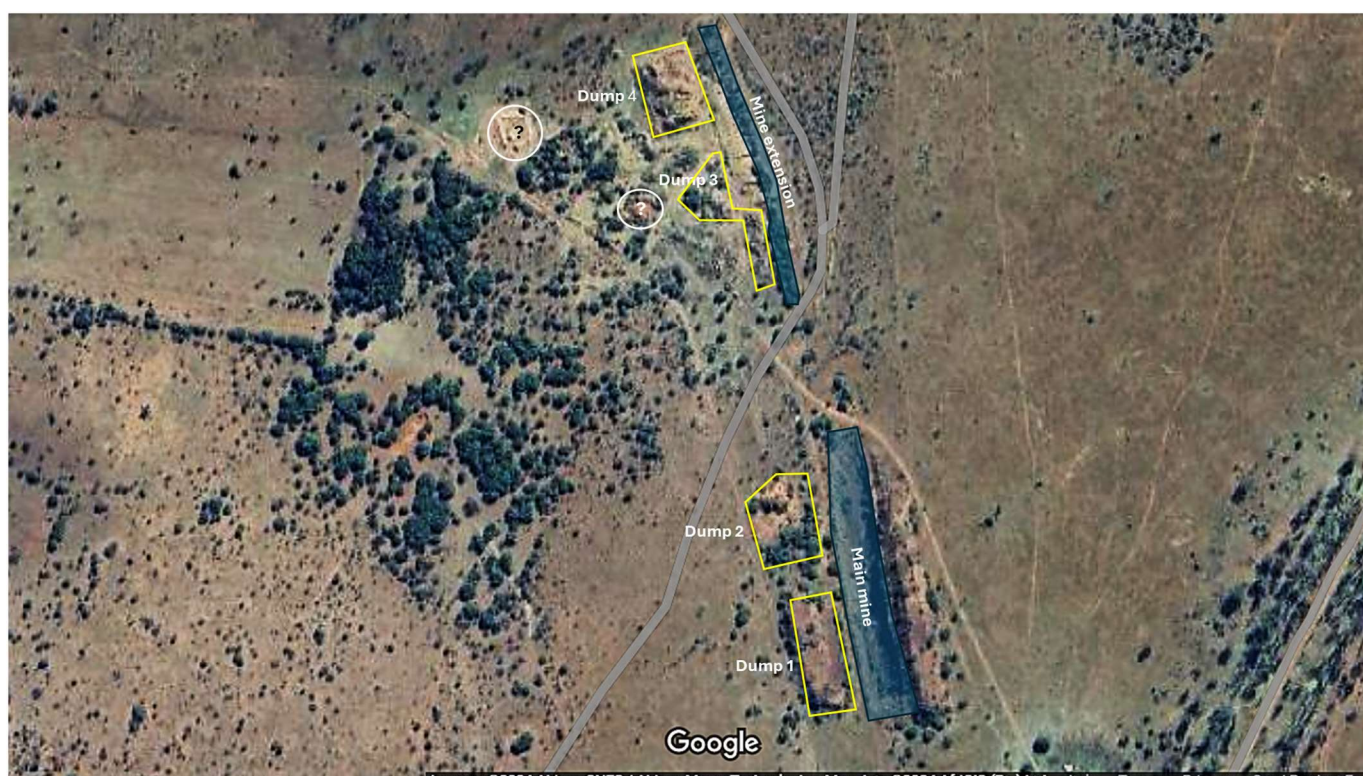
Figure 2: Ottoshoep old mine site. NB dump #5 falls outside (to the North) of this picture

Five (5) dumps were identified within the old mining area. Figure 2 shows the Google satellite image of the area with the positions of the dumps and other mining features.

On the Google satellite map one can see two other sites that appear to be made of finer tailing material (indicated with “?” in white circles in Figure 2). Unfortunately, due to time constraints, these 2 sites were not visited. However, from the satellite image they appear to be made of finer material and hence could be tailing dumps, i.e. made of processed ore. If correct, these tailings could be of some value in term of the overall gold potential of the Project, even though their sizes are very small.

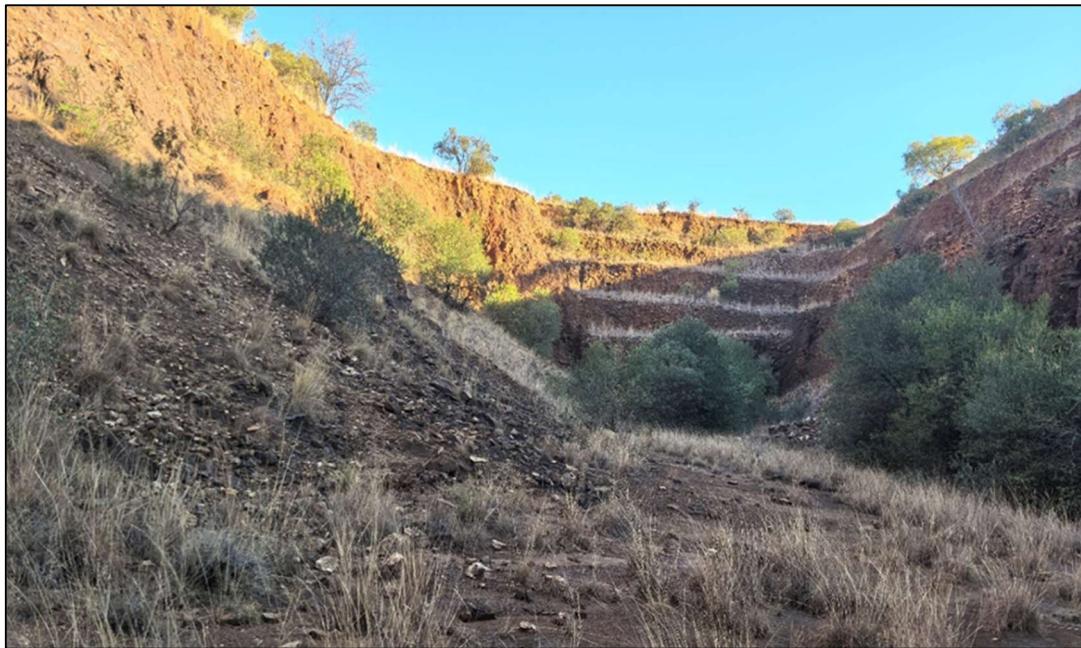
Figure 3: Main pit, southern end

- There is an old open pit mine 300m long in a NS direction, about 30m wide and about 30-50m deep. The mine floor was completely dry and easily accessible from the North entrance ramp. Illegal artisanal mining activities are taking place inside this open pit and the surrounding areas. There are two recently dug pits at the bottom of the mine with an underground channel connecting the two pits. Figure 3 shows the southern part of the mine and figure 4 a vertical section of the mine sidewalls.

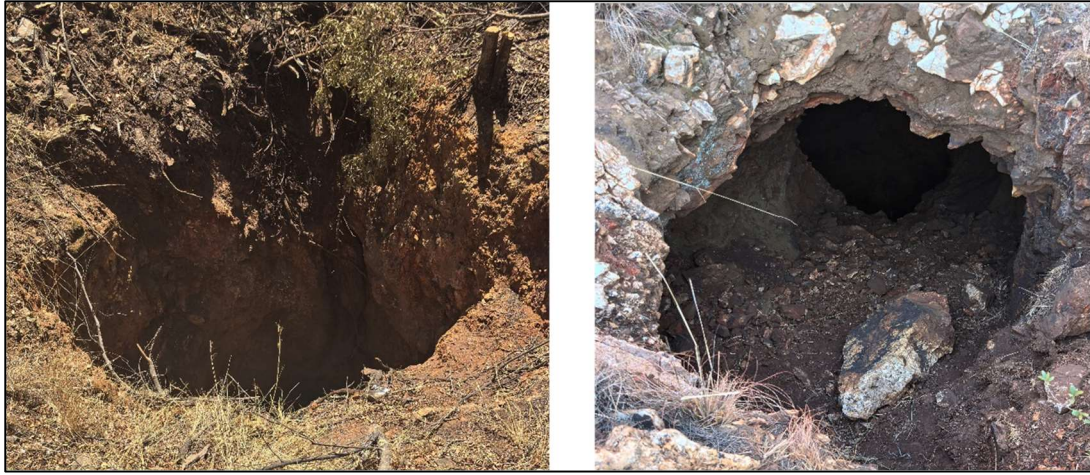
Figure 5: Examples of pits dug inside the old mine open pit

- Twenty-five (25) holes of various depths (3m to 20m or more) were observed. These pits are scattered in the area. Most of them are old, but few are fresh due to current illegal mining activities. Figure 5 illustrates examples of the pits found in the area. Most of the recently dug holes are situated inside the old open pits; clearly the illegal miners are targeting the extensions at depth of the gold “reefs”.

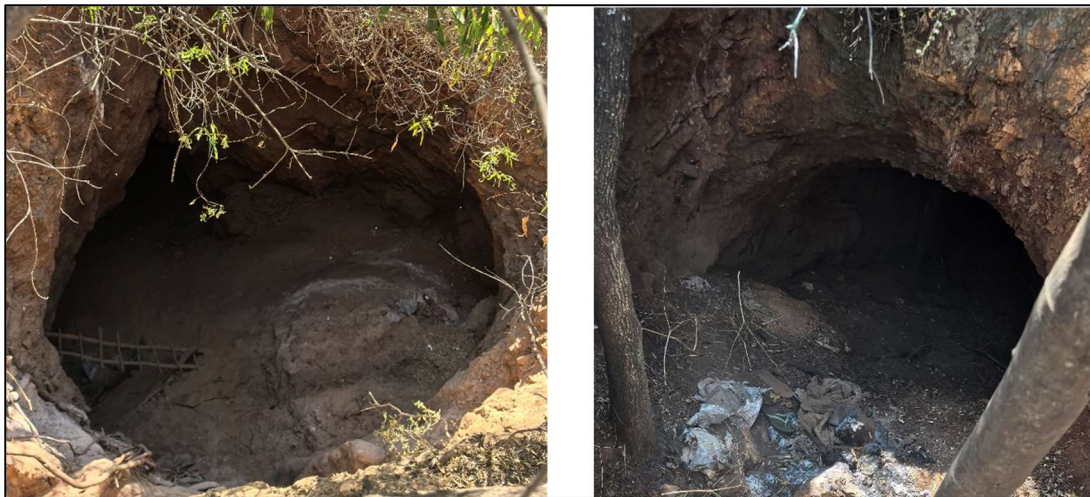
Figure 6: Examples of tunnels dug inside the old mine open pit

- Two underground mining tunnels are present toward the NW of the main open pit mine. The two channels are about 2.5m high and then extend horizontally to about 30m underground. The illegal miners use these tunnels to hide themselves inside when running away from security. Figure 6 displays examples of the underground mining tunnels.

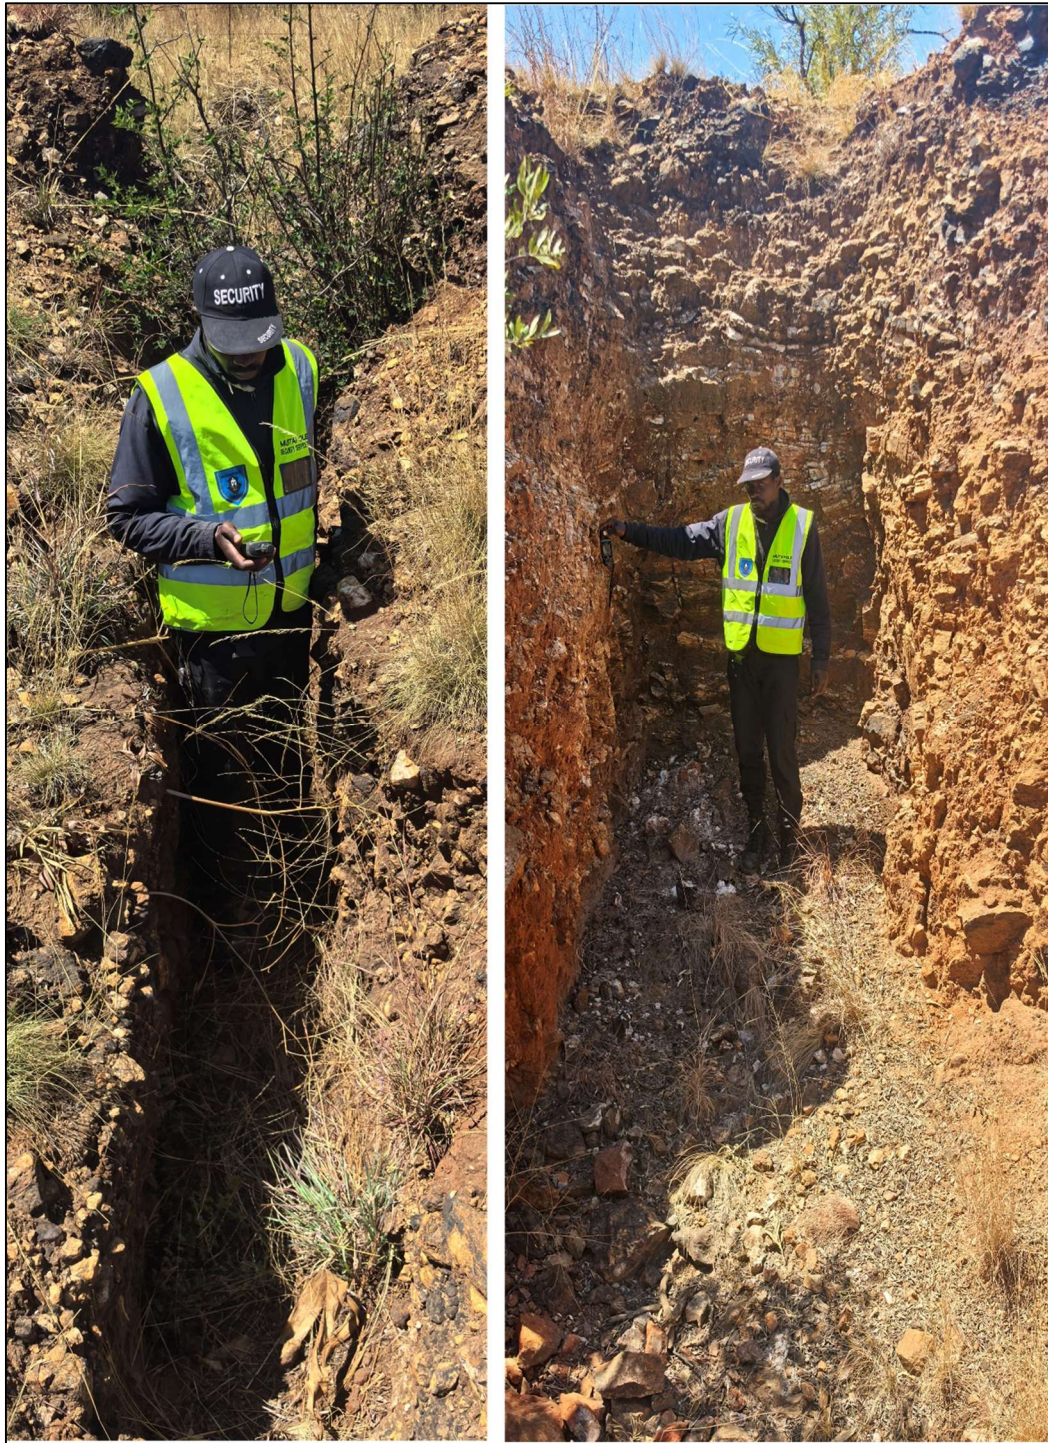
Figure 7: Examples of trenches excavated around the mine area

- At least 6 trenches were observed in the area (but there are more). Most of them are 1 to 3m deep and 15 to 30m long. Three of the visited trenches are E-W oriented and the other three are N-S oriented. The longest trench, about 70m long, is N-S oriented, in line with the main open pit mine. There are seven pits aligned inside this trench. Three of these pits are fresh due to recent illegal mining activities. Figure 7 is an illustration of the trenches.

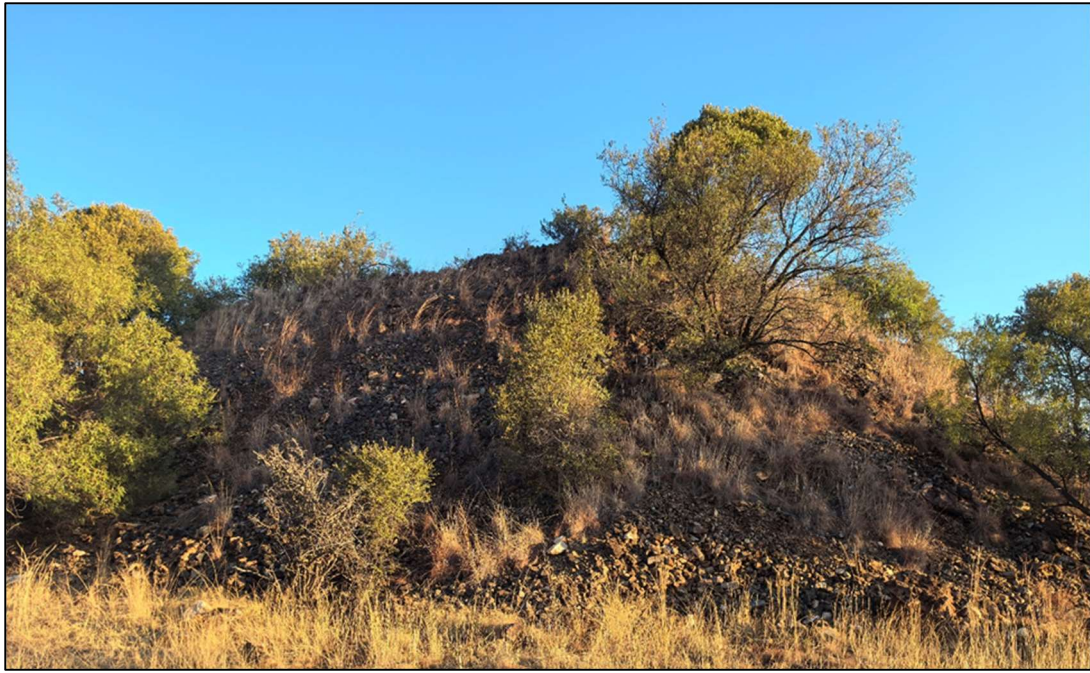
- **Dump 1.** It is situated next to the main open pit mine, about 25m away on the western side (Figure 2). This dump could be about 10-15m high, 120m long and 40m wide with gentle side slopes, easy to access from the South. A drill rig could access the top part (Figure 8). Due to its position (adjacent and parallel to the main open pit) and its general composition (mainly rocks and coarse, unsorted material), we believe that this dump is made of waste material excavated from the pit (to access the gold reef); if correct, then this dump likely has no potential in term of gold content.

Figure 8: Dump 1 - view from the N. A gentle slope is observed at the top from North to South

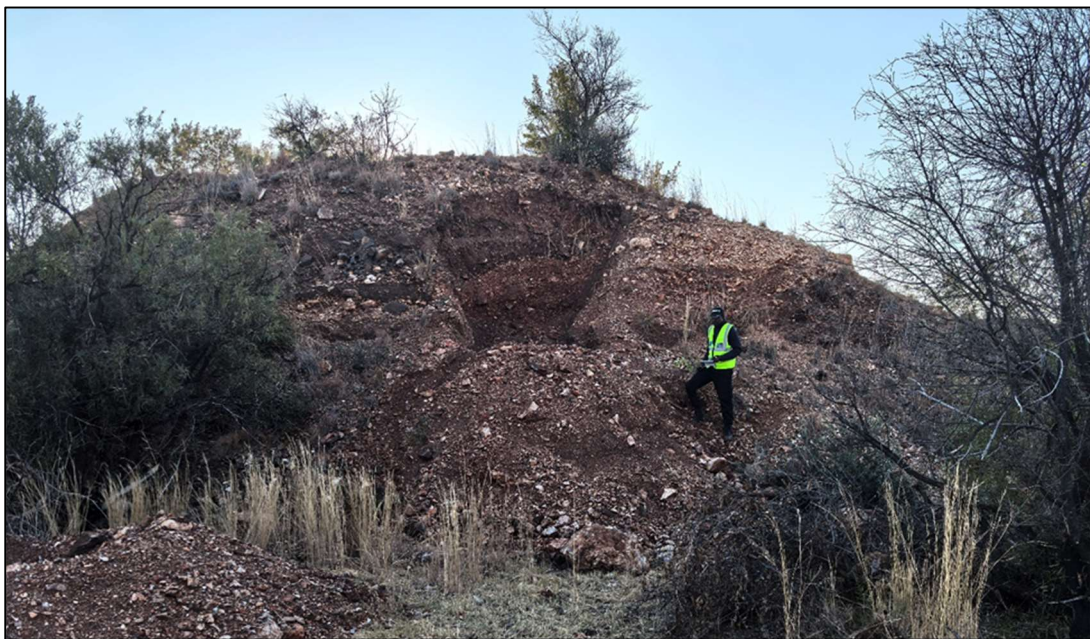
- **Dump 2.** It is located toward the northern section of the main open pit mine (Figure 2). This dump is about 10m high, 40m long and 30m wide. In fact, the shape of this dump is irregular with steep slopes (Figure 9). Access to the top is not possible for a rig except if a way is created with a bulldozer. It appears that some material from the northern part of this dump may have been reprocessed and if so, this dump could be considered in the evaluation programme.

Figure 9: Dump 2 – view from the N

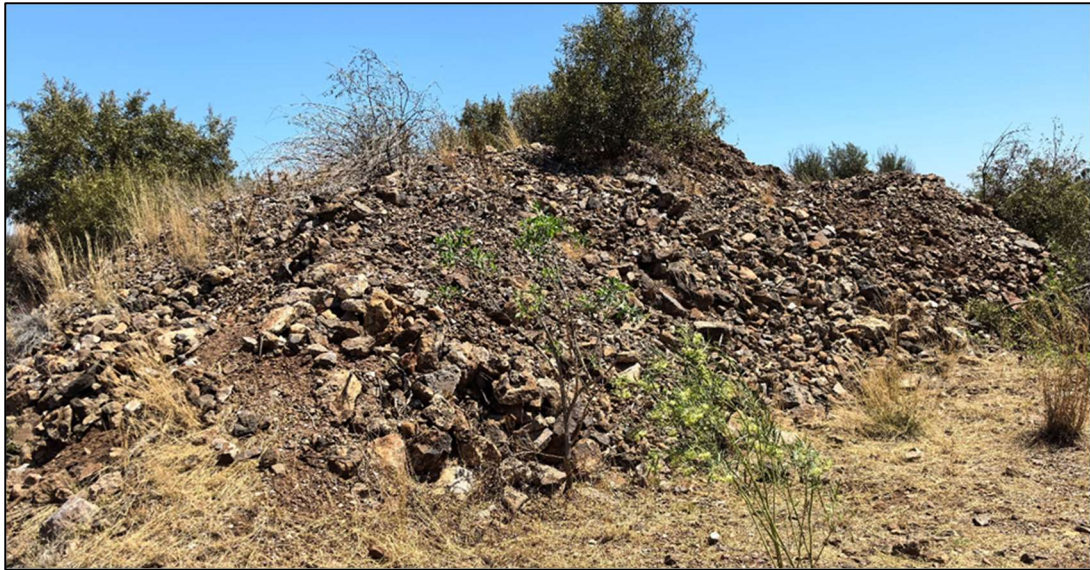
Figure 10: Dump 3 – view from the E

- **Dump 3.** Located c.300m NW of the main open pit mine access ramp and close to dilapidated buildings, this dump is composed of three (or 4?) groups of spoil heaps maximum 5m high, each with a couple of metre space in-between (Figures 2, 10 and 11). Grouping the heaps together, this dump would have a dimension of c. 130m x 20m. The general shape of the dump is irregular hence the general dimensions given

above are just indicative. Access to the top of the dump is not possible except if a way is created with a bulldozer. The heaped form of this dump and its composition (mixture of coarse/rocks and fine material) seem to suggest that we may be dealing with stockpiles for feeding into a plant. Similarly to dump 2, dump 3 appears to have seen some excavation for reprocessing of the material, hence it could have some gold potential, albeit probably quite low.

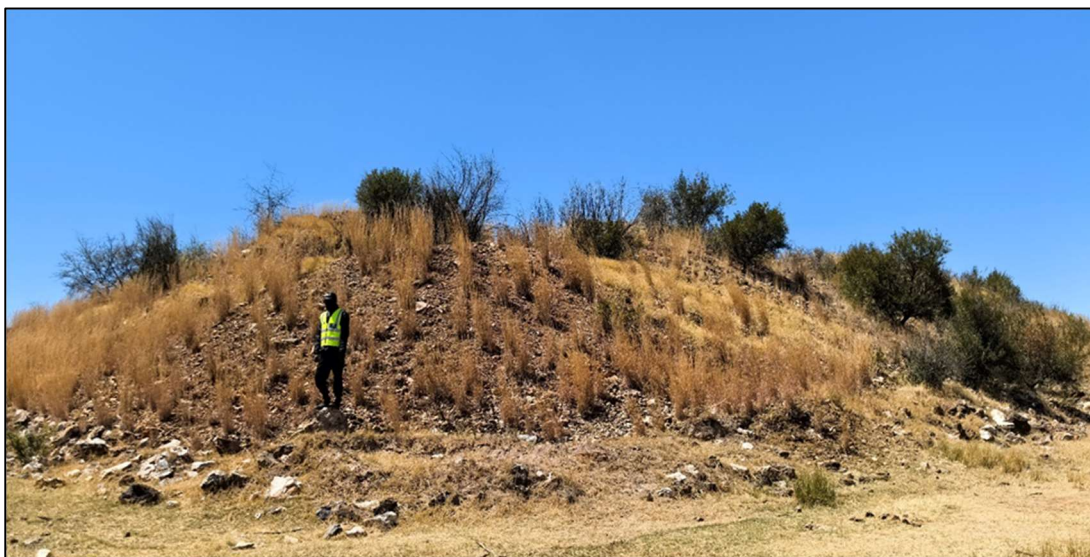
Figure 12: Dump 4 – view from the N

- **Dump 4.** Located about 400m NW of the main open pit mine access ramp, this dump is probably the most promising in term of gold potential, at least in term of volume/tonnage. It has a roughly rectangular shape (Figure 2) with steep side slopes. The length of the dump was estimated to be 80m with about 50m width and 5-7m height. The dump appears solid at surface, strong enough for siting and moving a drilling rig on its top (Figure 12). It appears to be composed of coarse material (rocks) mixed with finer material (sand) (Figure 13) and could represent a stockpile for feeding into the plant. If a sampling programme is carried out, this dump 4 should be first priority.

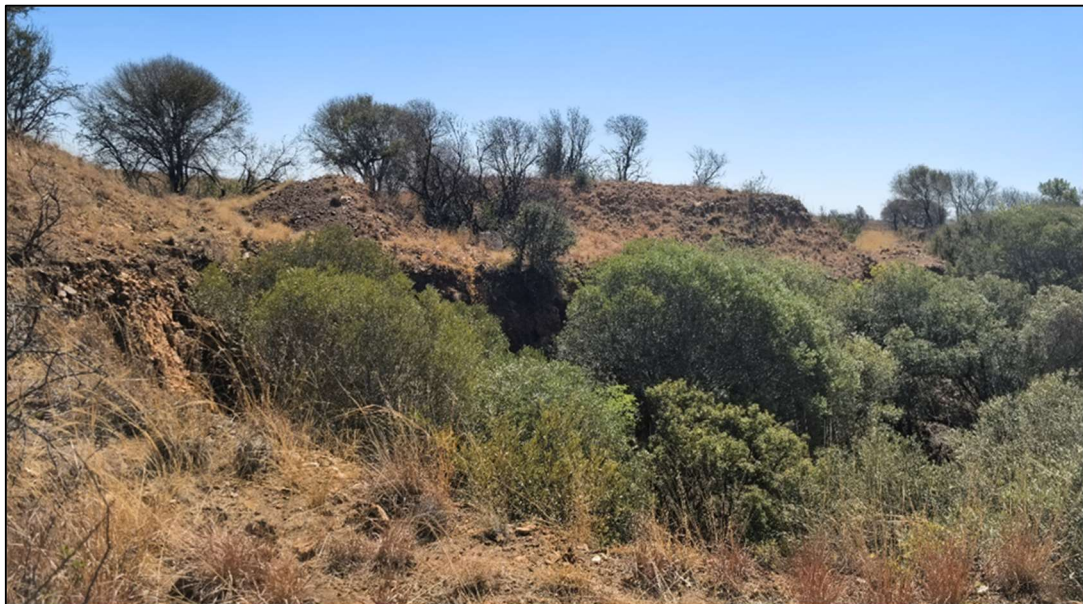
- **Dump 5.** It is located c.750m away NW of the main open pit mine entrance ramp. This dump is composed of several spoil heaps about 3 to 5m high each. The size of each group is relatively small with irregular shapes (Figure 14). It appears that the material is waste rock excavated from the relatively small open pit next to it; and if so, together with the relatively small size of it, this dump is likely to have no gold potential.

Figure 14: Dump 5 – small heaps next to shallow open pit, looking W

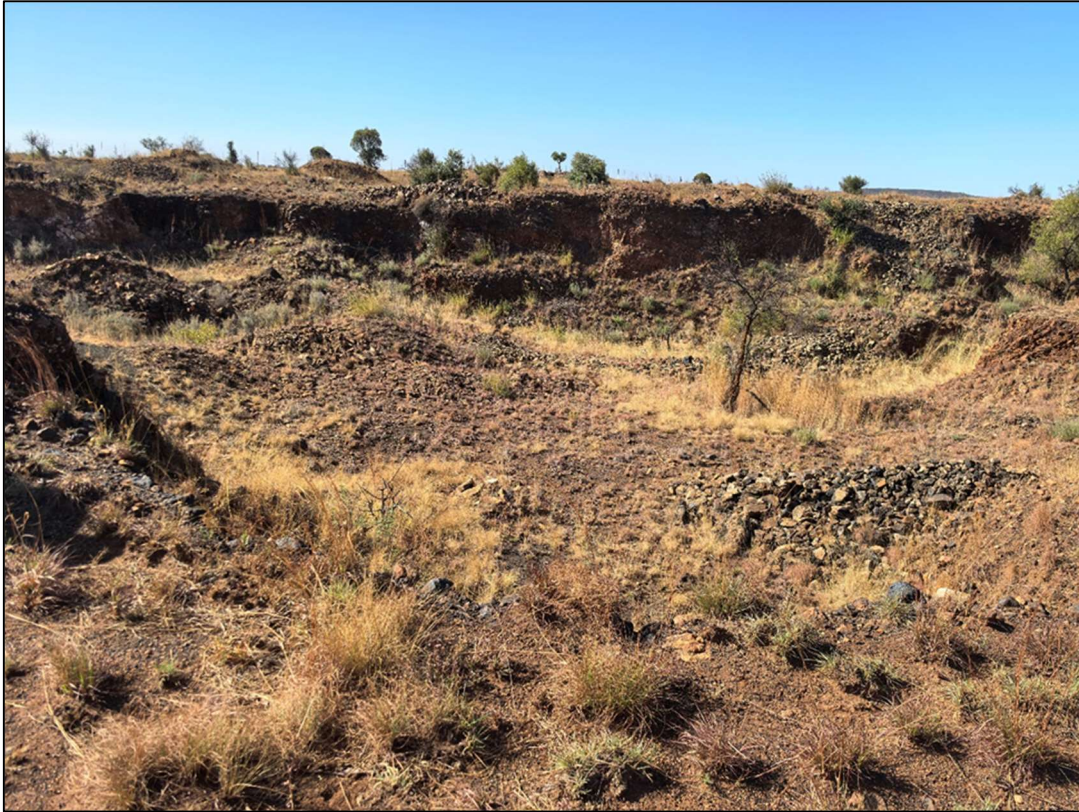
Figure 15: Open pit manganese mine, view from S

- Some 2.5km North of the gold mine, there is also another old open pit which was apparently excavated for Manganese (Figure 15). This Mn open pit is about 30m in diameter with 2-5m depth. Access to the bottom of this pit is easy from the West.
